## HEALTH CARE ARCHITECTURE IN SÃO PAULO, BRAZIL: EVALUATING ACCESSIBILITY AND FIRE SAFETY IN LARGE HOSPITALS

Sheila Walbe Ornstein, Rosaria Ono, Maria Elisabete Lopes,  
Monteiro, R.Z., Gill, A.A., and Machry, H.S.

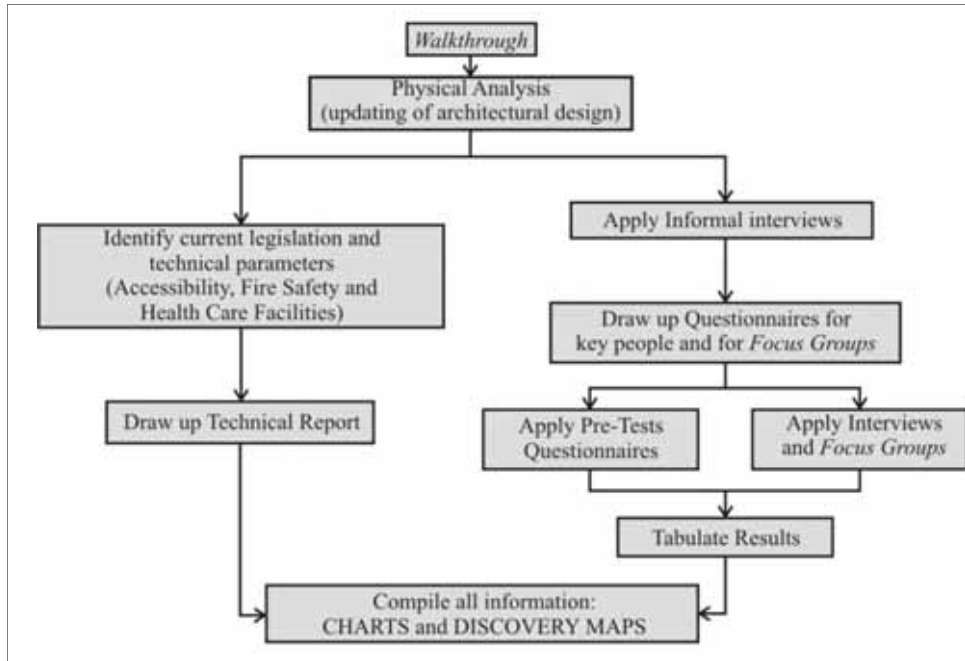
Figure 3:  
Flowchart of  
the Process for  
Developing a  
Post Occupancy  
Evaluation (POE)  
Mechanism.

the decisions and who are not familiar with the matters at issue. The flowchart of the process is presented briefly in Figure 3.

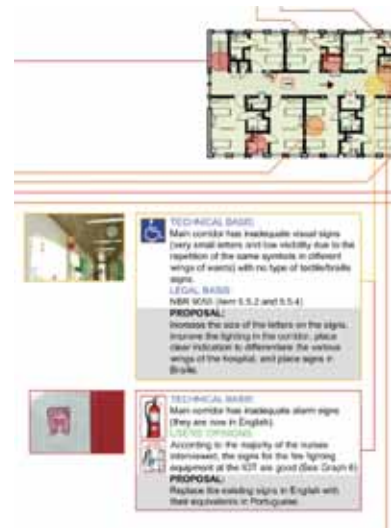
Figure 5: Section of the Discovery Map for the Second Floor of the IOT Building.
